VALUE MANAGEMENT ANALYSIS
AFTON ELEMENTARY SCHOOL
Edmonton, Alberta

EDMONTON PUBLIC SCHOOLS

N53 ARCHITECTURE INC

AUGUST 21, 2016

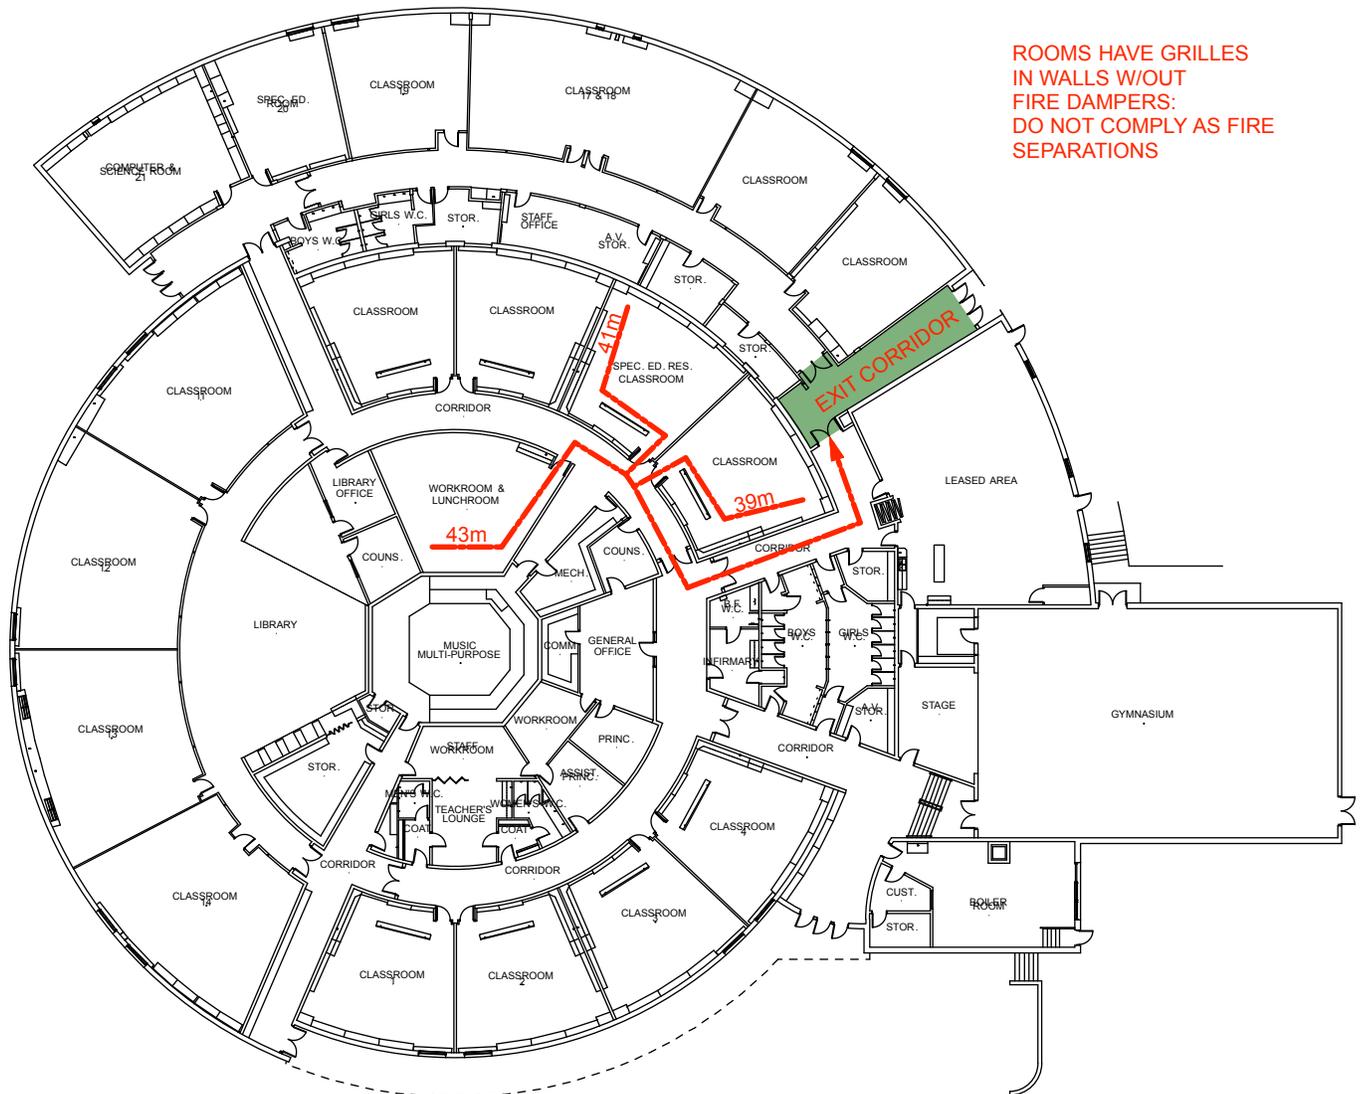
ROOMS HAVE GRILLES
IN WALLS W/OUT
FIRE DAMPERS:
DO NOT COMPLY AS FIRE
SEPARATIONS
